Manhole Inspection Summary

Manhole # S43C__002MH

Insp Date: **4/22/08 8:51 AM**

Location Address: **Fayette St**

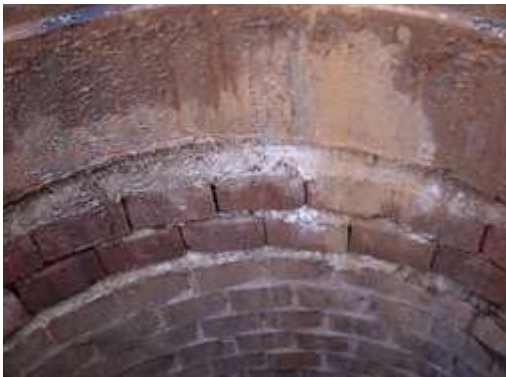
Defect 1

☒ **Leaks**

Frame Leaks

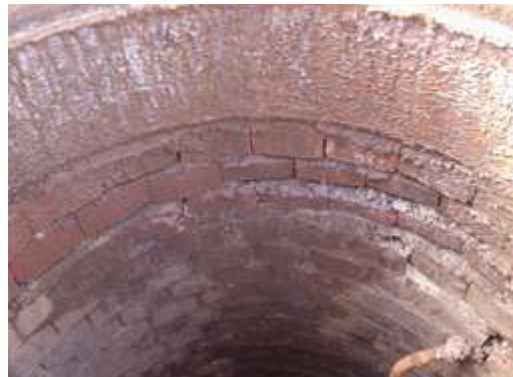
Defect 2

☒ **Mortar**

Infiltration

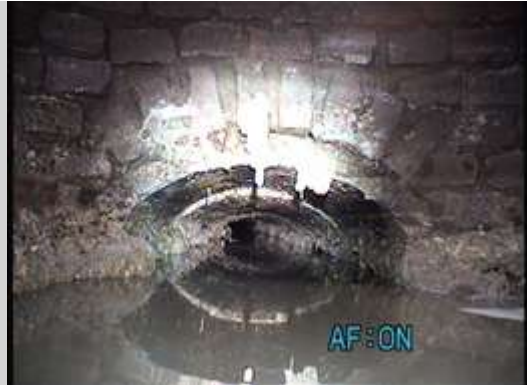
12 O'Clock Outflow

21 in. Circular Gravity Sewer
Pipe Out @ 12 O'Clock

Pipe Height: **21.6** (in.) Rod and Bar (Angled)
Pipe Material: **Clay** ☐ Pipe Lined
Invert Depth: **13.90** (ft.) Flow Characteristics: **Slow**
Deposits: ☒ None ☐ Mud ☐ Sludge ☐ Debris ☐ Grease
Silt Depth: (in.) Deposits Extent:
Infiltration: **None** Pipe Seal Cond: **Sound**

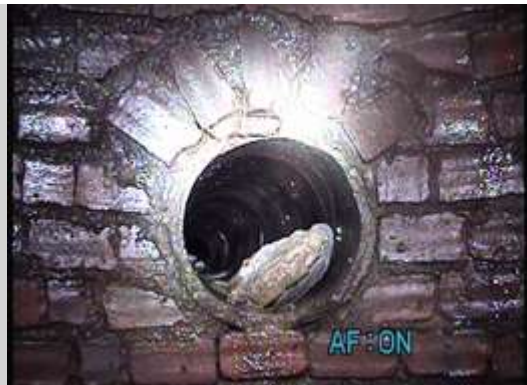
3 O'Clock Inflow

8 in. Circular Gravity Sewer
Pipe In @ 3 O'Clock

Pipe Height: **8.4** (in.) Rod and Bar (Angled)
Pipe Material: **Clay** ☐ Pipe Lined
Invert Depth: **9.00** (ft.) Flow Characteristics: **Fast**
Deposits: ☒ None ☐ Mud ☐ Sludge ☐ Debris ☐ Grease
Silt Depth: (in.) Deposits Extent:
Infiltration: **None** Pipe Seal Cond: **Sound**

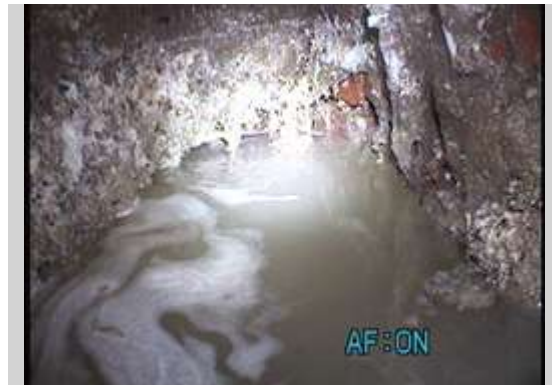
Drop In @ 3 O'Clock

Drop: **Inside** Rod and Bar
Angled: **Yes** Reading: **13.30** (ft.)
Inv Depth: **14.30** (ft.)
Drop Condition: **Open**

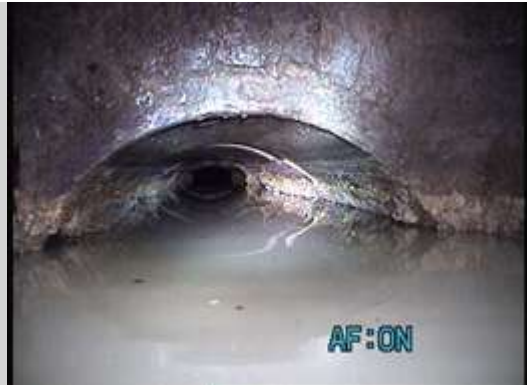
6 O'Clock Inflow

15 in. Circular Gravity Sewer
Pipe In @ 6 O'Clock

Pipe Height: **15.6** (in.) Rod and Bar (Angled)

Infiltration: **None** Pipe Seal Cond: **Sound**
